Measuring the Surface Evenness of Cycle Paths

Anna Niska, VTI

Swedish National Road and Transport Research Institute, Linköping, Sweden

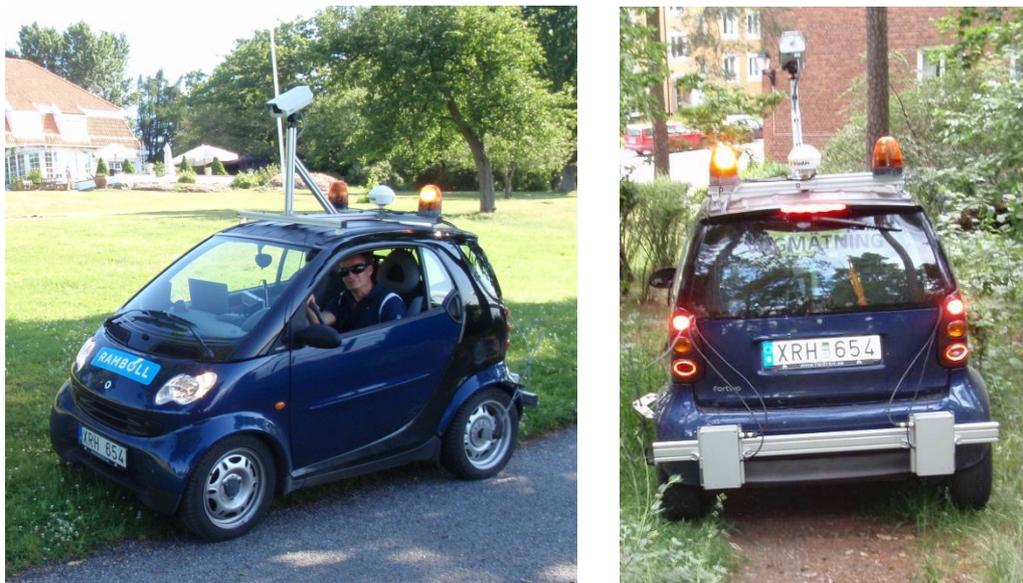
Figure 1. The small car equipped to measure the longitudinal profile of cycle paths

will focus on, a method for measuring the surface evenness of cycle paths was tested and evaluated. The method is based on measurement of the cycle path's longitudinal profile with two laser sensors mounted in the rear of a small car that is also equipped with a GPS and a camera (Figure 1). The camera automatically takes pictures of the cycle path surface and its environment every ten meters during measurement. There was also a control board in the vehicle with a set of buttons that the driver could push to manually record surface defects or other features that could affect the measurement.

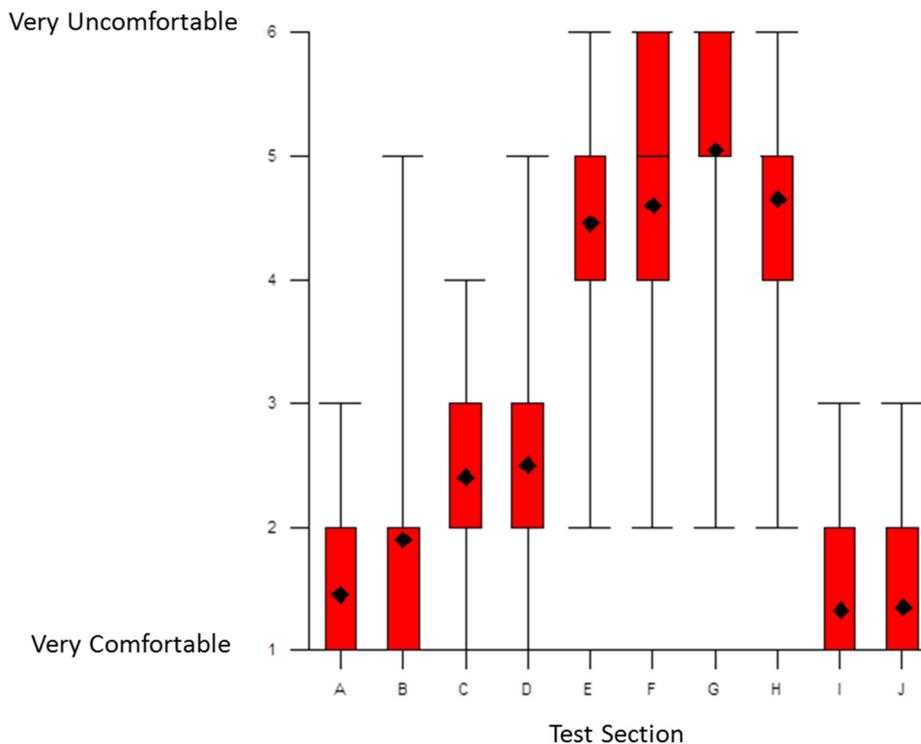
Figure 2. The cyclists' average assessment of the test sections in Malmö. Sections A and B were assessed a second time at the end of the loop, denoted "I" and "J" in the figure. The boxes are showing 25- and 75-percentiles of assessment values, mean values are marked with black dots and whiskers are showing minimum and maximum values.

It was found that it was difficult for the cyclists to ignore the surroundings and to assess only the surface itself, and that there was a large individual difference in the assessments done by different cyclists. It is therefore difficult to draw conclusions on what the "average" cyclist thinks, but it was nonetheless possible to make a distinction between assessments of the different sections (Figure 2).

The average assessment made by the cyclists corresponded well with the visual classification made prior to the test, when choosing test sections, with A and B being smooth and even and E to H having many deficiencies. In addition, the cyclists' relative assessment corresponded well with their absolute assessment.
